## DHI CASE STORY

# RIVER MOUTH TRAINING IN THE BAY OF PLENTY

## Designing twin training walls for the dynamic Opotiki Harbour Entrance

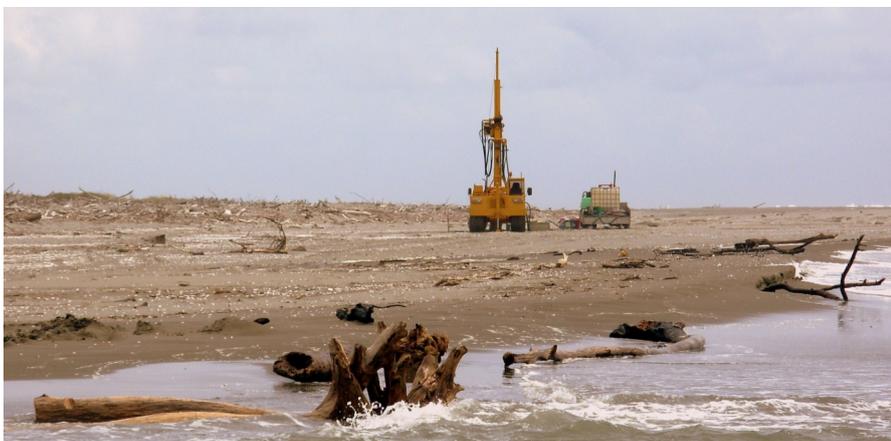
Samples being collected from the Opotiki Harbour Entrance © DHI

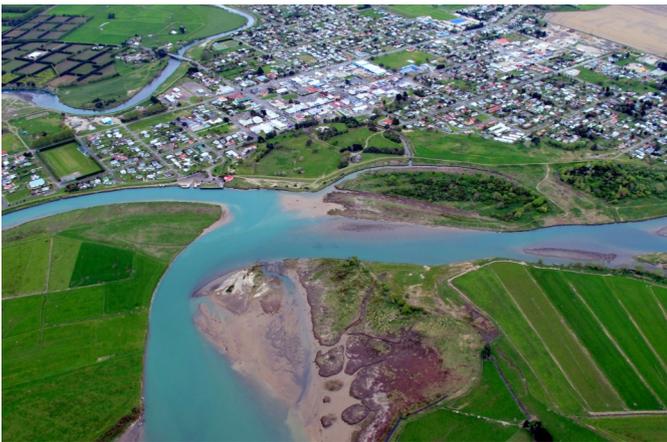
*Opotiki sits at the confluence of the Otara and the Waioeka rivers*  
© DHI
